A NEW METHOD FOR STATOR CORE REPAIR REDUCES CORE LOSSES AND REPAIR TIME

Copyright Material IEEE
Paper No. PCIC-2006-14

Abstract — The steel laminations used in the stator core of electric motors and generators are electrically insulated from one another to reduce eddy-current losses. When a bearing failure results in friction between the rotor and stator, or a ground fault occurs, laminations are often fused together. Since traditional methods of core repair are labor-intensive, even moderate core damage may preclude economical repair in the few percent of motor failures with significant core damage. There is a new process that can restore the coreplate without dismantling the core, saving labor and eliminating the chance of unsatisfactory restack results. This chemical conversion process simultaneously etches interlaminar shorts and forms a durable coreplate with excellent electrical insulation. The potential benefits to industry, in terms of labor saved and reduced mean time to repair, are substantial. The cost to restack the stator core of a 5,000 kW machine can exceed \$30,000 US, and require two weeks time. This new process can restore the core in less than one day.

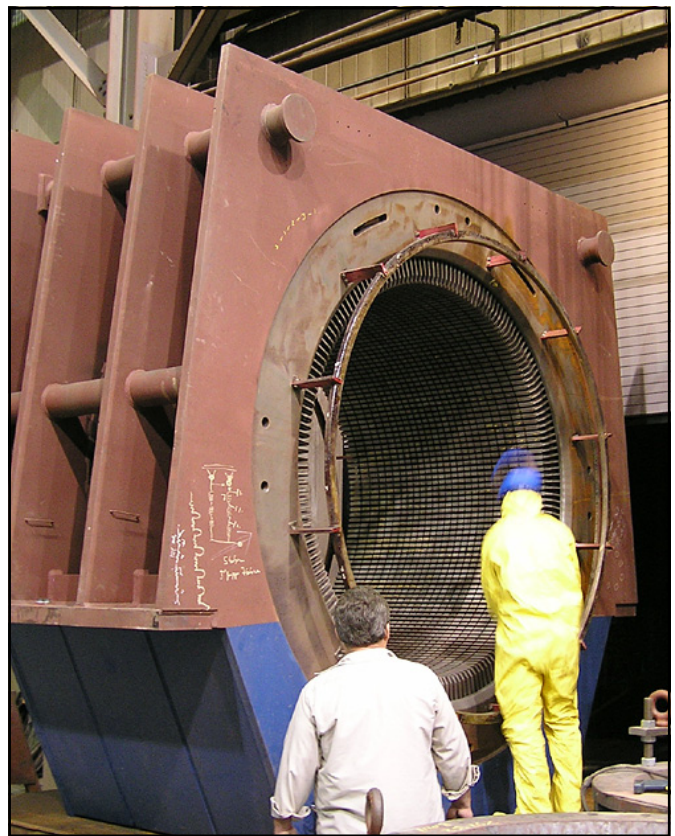
Fig. 1. A 9.5 MW stator core being prepared for the new treatment.

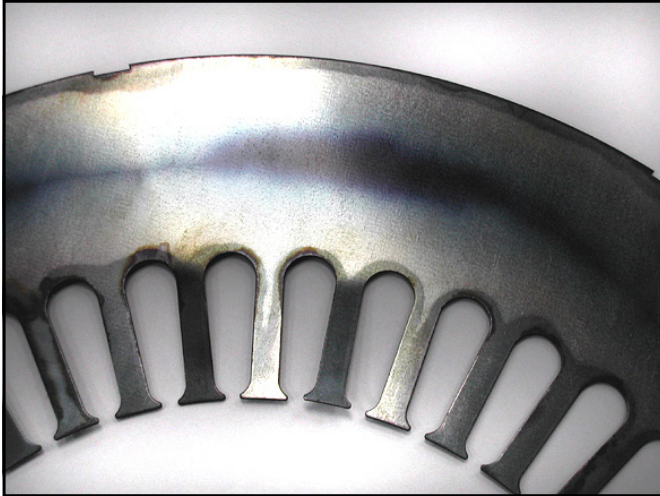
Fig. 3. The differences in color and coreplate formed on the backiron of this lamination illustrate what happens when cycle time is too short.

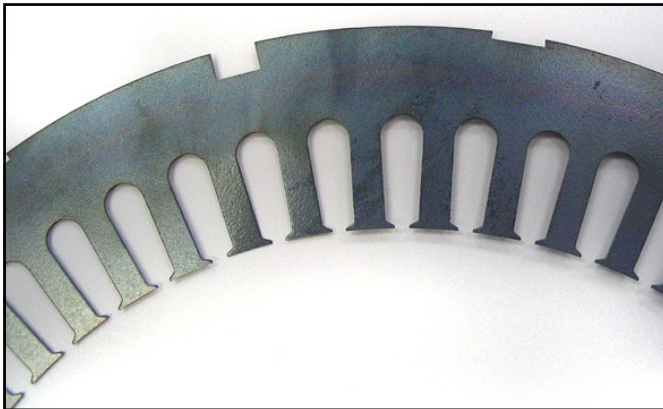
Some manufacturers use a less well-controlled process, which results in a "steam blued" coating – a thin blue coating as in Fig. 4.

Fig. 4. An inferior oxide coating with blue coloration.

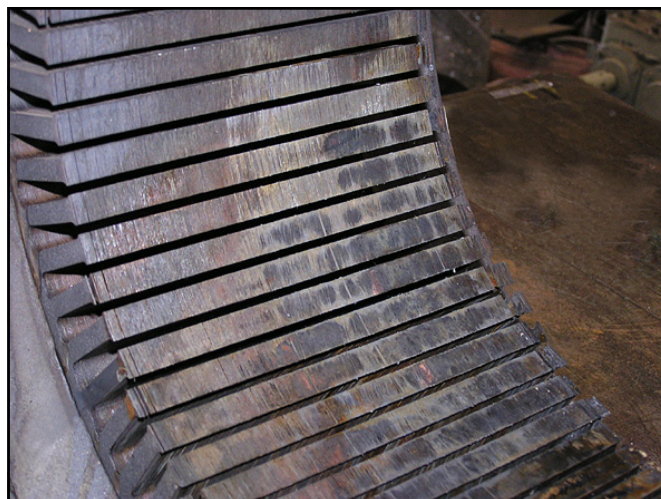
Fig. 6. A bearing failure results in friction between rotor and stator, with subsequent increase in core losses.

This NEMA 405 frame stator (Fig. 6) was not fanned (laminations spread individually), watt-knocked or otherwise prepared prior to the etching treatment. Ambient temperature was 22° C (71° F).

Core loss watts/kg (watts/lb)	Power factor	Hot spot temperature
Before	9.09 (4.21)	0.67	53° C (128° F)
After	5.05 (2.34)	0.58	28° C (83° F)

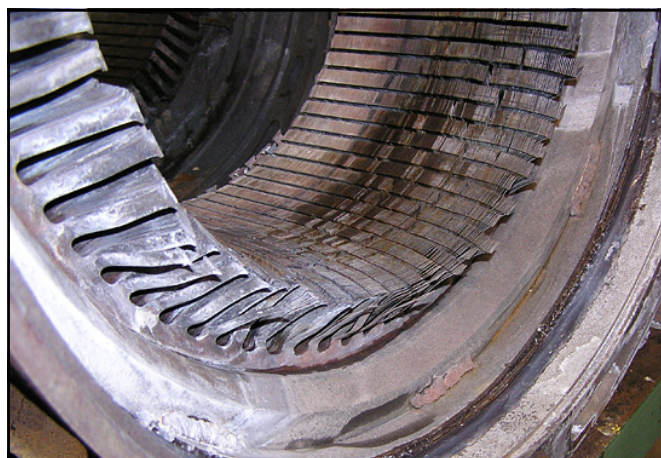
Fig. 7. Core repair by separating fused laminations and reinsulating them is labor intensive.

This NEMA 405 frame stator (Fig. 7) was fanned (laminations spread individually) and processed. Ambient temperature of the core was 22° C (71° F).

Core loss watts/kg (watts/lb)	Power factor	Hot spot temperature
Before	8.10 (3.75)	0.70	43° C (109° F)
After	4.23 (1.96)	0.50	23° C (74° F)

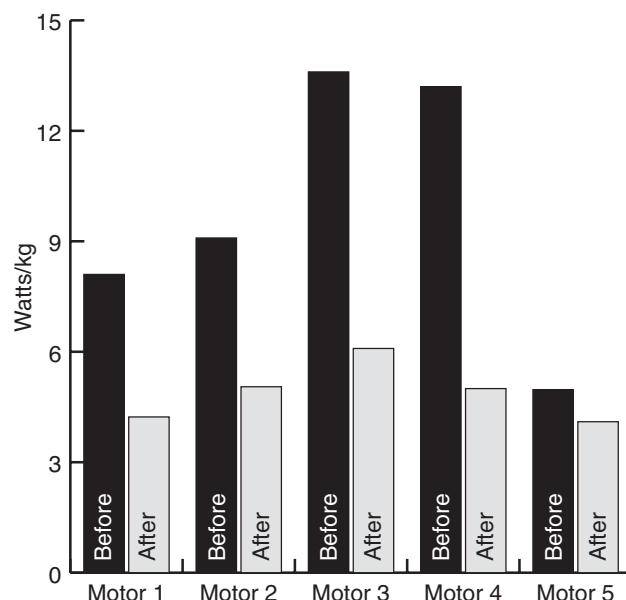
Fig. 8. Improvement in watts loss. Also see Appendix B.

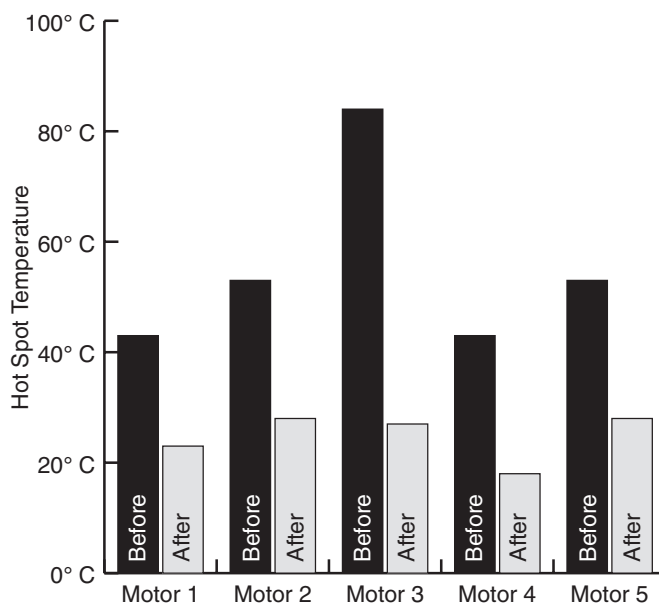
Fig. 9. Reduction of hot spot temperature. Also see Appendix B.

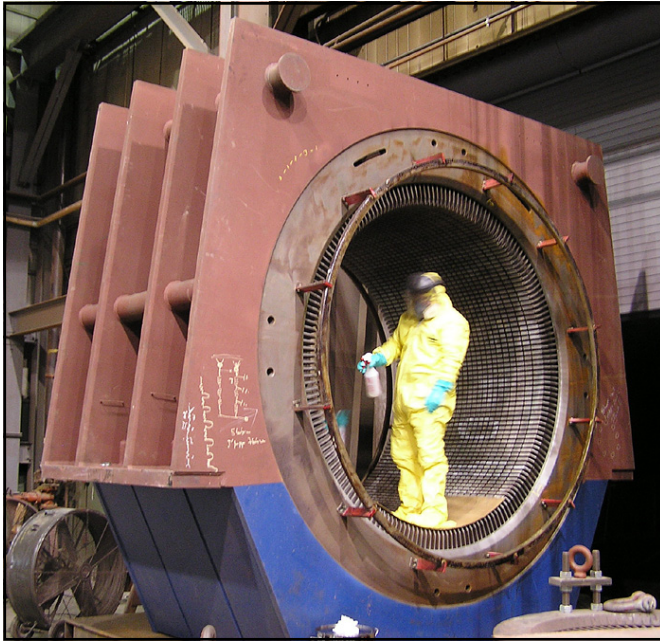
The 9.5 MW core weighed 17,250 kg (38,000 pounds), with a core length of 203 cm (80") and a bore diameter of 216 cm (85"). Widespread shorting of the core included the surface and numerous slots, as evidenced by the thermal images in Appendix C. Visual examination of the stator core revealed that the core is

Fig. 10. The 9.5 MW stator core being treated with the new process.

Damaged areas of the core were carefully marked during the core loss test, and thermal images taken to document the condition of the core. The core was baked for 24 hours at 99° C (210° F) prior to treatment. The solution was heated and applied by two technicians wearing full personal protective equipment (PPE) (Fig. 10). Keeping the damaged areas continuously wetted was challenging given the size of the core. (A pressurized applicator would be more practical for a core of this size.) Following treatment, the core was pressure-washed with cold water, and allowed to dry.

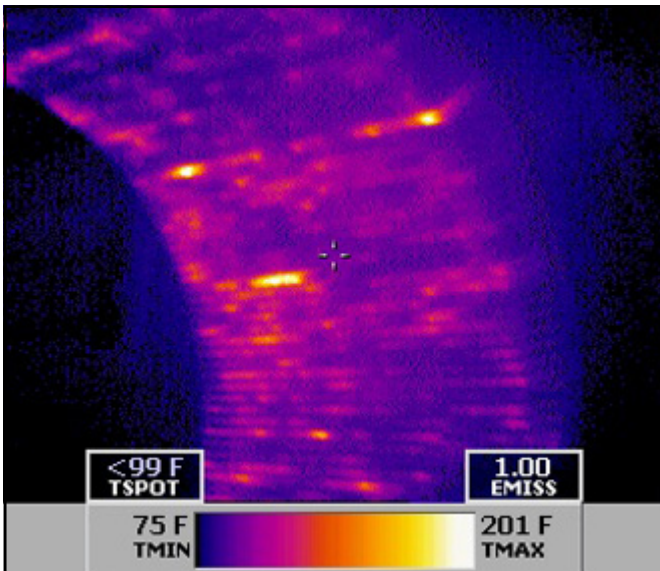
to use plastic or glass beads. Unfortunately, it was later discovered that the outside contractor had not completely removed the aluminum oxide from the hopper before cleaning this core. This resulted in the localized surface heating visible in the thermal image in Fig. 11.

Fig. 11. With the exception of small areas of surface damage caused by aggressive blast media, the temperature of the entire core was reduced by ~40° C (50° F).

A drum sander was used to scrub the surface in those areas, during the loop test, which cleared surface shorts and decreased the temperature to that of the rest of the core.

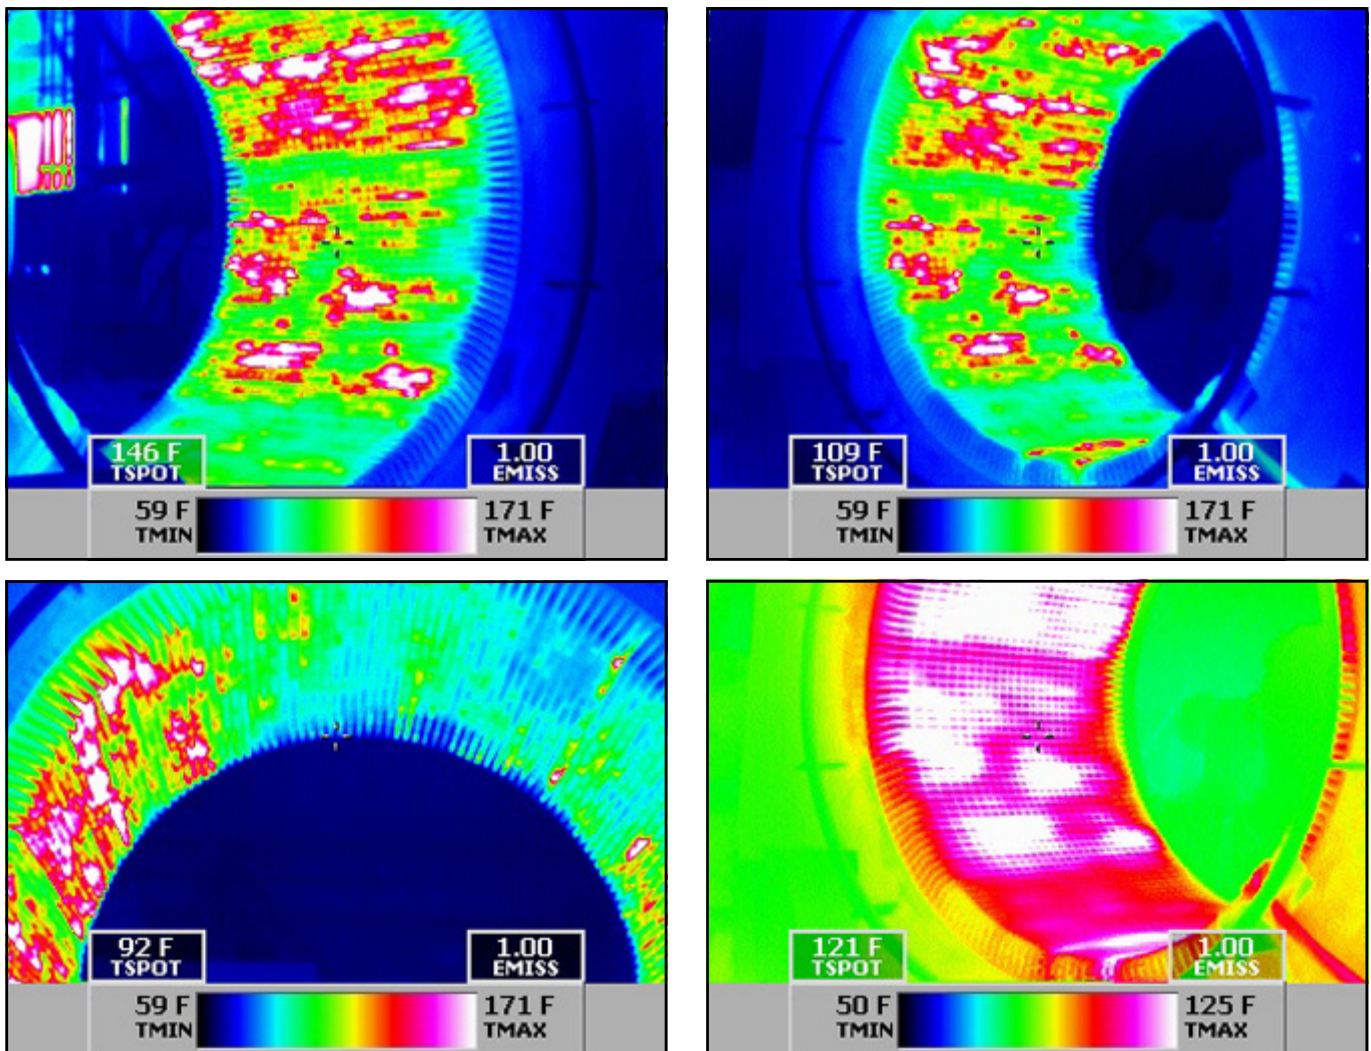
Fig. C-1. Thermal images taken before the 9.5 MW stator core was treated. Note the widespread heating.

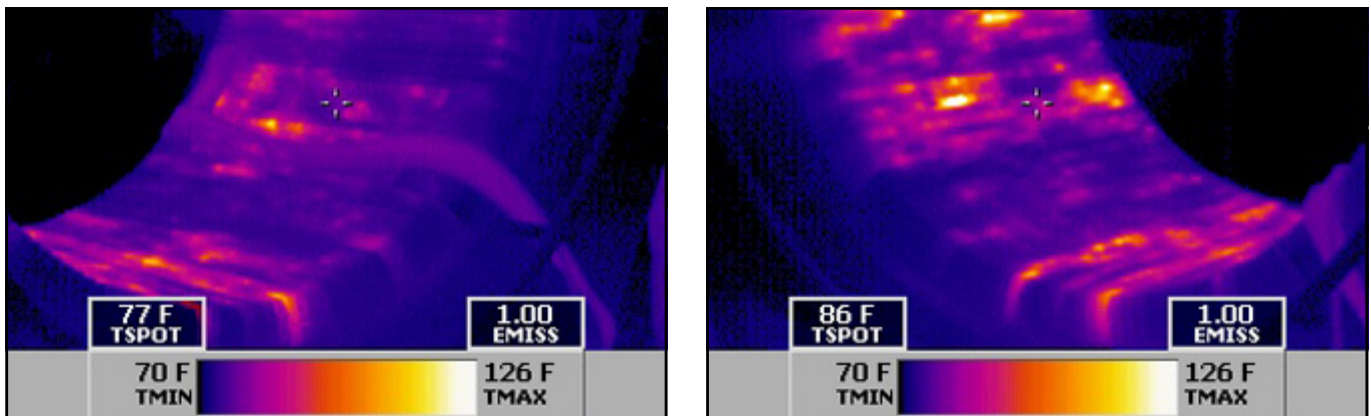
Fig. C-2. The same 9.5 MW stator core after treatment. Average temperature was reduced approximately 50° F. The small localized hot spots on the surface are believed to be the result of abrasive blasting by an outside contractor.
