A NEW METHOD FOR STATOR CORE REPAIR REDUCES CORE LOSSES AND REPAIR TIME

Copyright Material IEEE
Paper No. PCIC-2006-14

Abstract — The steel laminations used in the stator core of electric motors and generators are electrically insulated from one another to reduce eddy-current losses. When a bearing failure results in friction between the rotor and stator, or a ground fault occurs, laminations are often fused together. Since traditional methods of core repair are labor-intensive, even moderate core damage may preclude economical repair in the few percent of motor failures with significant core damage. There is a new process that can restore the coreplate without dismantling the core, saving labor and eliminating the chance of unsatisfactory restack results. This chemical conversion process simultaneously etches interlaminar shorts and forms a durable coreplate with excellent electrical insulation. The potential benefits to industry, in terms of labor saved and reduced mean time to repair, are substantial. The cost to restack the stator core of a 5,000 kW machine can exceed \$30,000 US, and require two weeks time. This new process can restore the core in less than one day.

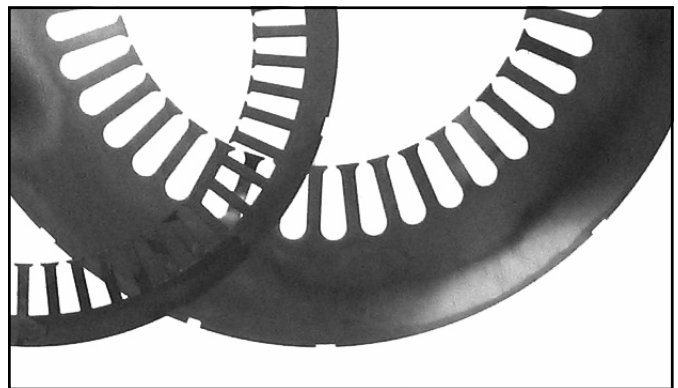
Fig. 2. The relatively large backiron of a 2-pole lamination requires more exposure time than smaller/low-speed machines.

When numerous sizes and designs of laminations (Fig. 2) are processed simultaneously in large batches, it is difficult to optimize the exposure time for all. Deviation from the correct mix of time, oxygen, humidity and temperature can result in formation of iron oxides other than the desirable Fe₃O₄.

Aside from those critical factors, other variables which affect quality control include the processing of large 2-pole laminations (more backiron area) with smaller and/or low speed laminations, stacking too many laminations, and surface rust present before oven processing. The lamination in Fig. 3 illustrates a common problem when a lamination passes through the oven too quickly. The circumferential band of color variation clearly indicates that the entire lamination did not reach the desired temperature.

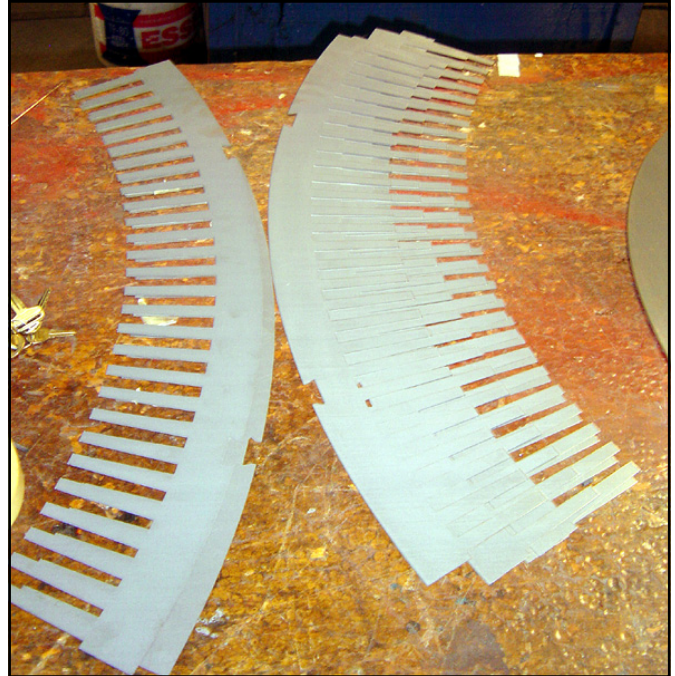
Fig. 5. Segmented laminations are typical for cores with bore diameters greater than 89 cm (35").

translates to delays in returning a motor to service, and considerable expense. Obtaining the correct stacking pressure [typically 5-8.8 kg/cm² (75-125 psi) of lamination area], and maintaining the stack geometry are but two potential problems. Cores with bore diameters 89 cm (35") and larger are often constructed of segmented laminations. These can best be described as a series of short arc-shaped pieces of lamination (Fig. 5) stacked end-to-end in a continuous spiral until the entire laminated core is formed. Orientation of the segments is critical. Inattention to detail may result in a core that is eccentric, tilted or otherwise departs from proper core geometry.

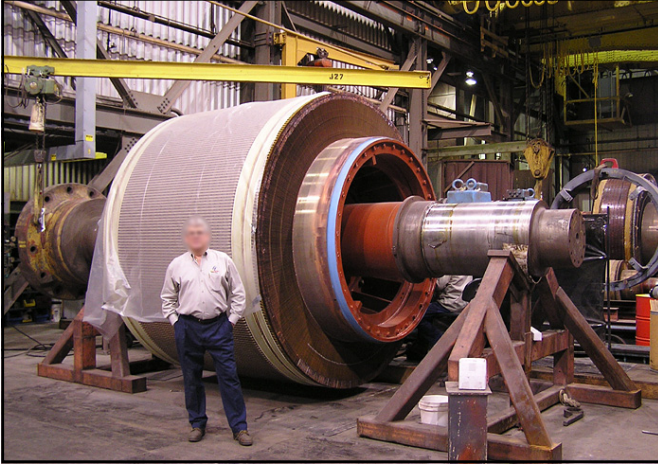
Treatment of brand new cores, donated by a manufacturer, indicate a modest reduction in core losses. This process should be useful to manufacturers, in reducing the reject rate of new cores. The process is applicable to DC armatures (Fig. 12), and

Fig. 12. DC armature cores can also be repaired using the new process.
